Confidential Home Inspection Report

75 Doe St.

Inspection ID: 7590S600W

Date: 4-24-2013

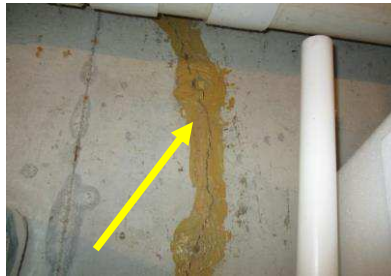
Full length crack back side of house basement wall. It is possible this condition is normal. Indications of prior issue with crack evident by past repair. Monitoring of crack recommended.

Full length crack on back side of house basement wall was observed. It is possible this condition is normal. Indications of prior issue with crack evident by past repair. Monitoring of crack recommended.

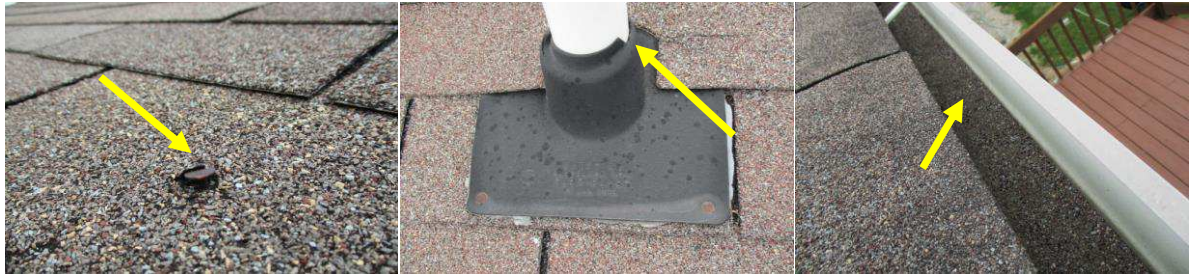
Exposed roofing fastener poking through shingle was found most likely due to roof age, which is estimated to be 15-20 years old. This makes water penetration through roof possible causing further damage.

There were cracks on all vent pipe boots do to age. Water penetration through these points are now possible. This could cause further damage.

There was evidence of significant granule loss observed in gutter.

Exposed roofing fastener poking through shingle was found this is most likely due to roof age, which is estimated to be 15-20 years old. This makes water penetration through roof possible causing further damage.

There were cracks on all vent pipe boots do to age. Water penetration through this point now possible causing further damage.

There was evidence of significant shingle granule loss observed in gutter.

Due to overall condition of roof further evaluation by a qualified roofing contractor is recommended.

Due to overall condition of roof, further evaluation by a qualified roofing contractor is recommended.

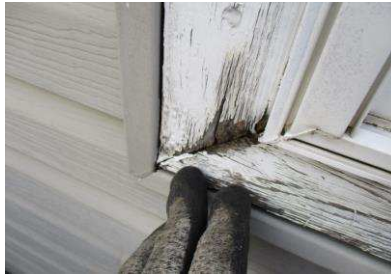
Significant wood rot was found mainly on windows facing driveway. Chances are this was caused by advanced age. If left uncorrected this can cause further water damage to house structure.

Double pane seals on 3 windows were broken. This was evident by conensation in panes.

Evidence of a significant energy leak found by infrared imaging on front side house window. Bad seal at bottom of window is most likely the cause. If left uncorrected, possible significant energy loss will be likely.

Significant wood rot was found mainly on window trim facing driveway. Chances are this was caused by advanced age. If left uncorrected this can cause further water damage to house structure.

Evidence of a significant energy leak was found by infrared imaging on windows on front side of house. A bad seal at the bottom of window is most likely the cause. If left uncorrected, possible significant energy loss will be likely.

Due to overall condition observed by inspector, further evaluation by a qualified window contractor is recommended.

Due to overall condition of windows observed by inspector, further evaluation by a qualified window contractor is recommended.

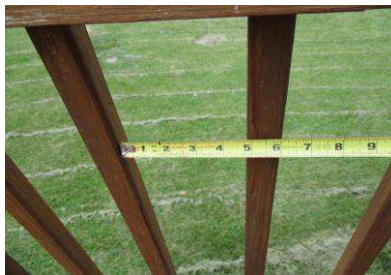
Choking hazzard for children found on upper deck balusters. Balusters should be spaced 4 inches apart or less. Recommended immediate correction by a qualified contractor.

Choking hazard for children found on upper deck balusters. Balusters should be spaced 4 inches apart or less apart. Recommended immediate correction by a qualified contractor.

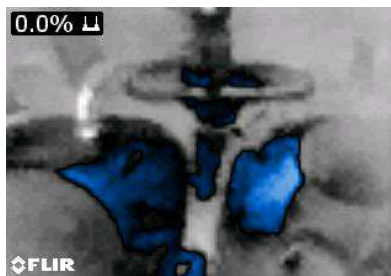
Evidence of water leak found at kitchen faucet found by infrared moisture imaging. Replacement of faucet is recommended. If not corrected this can cause further water damage.
